RENOVATION OF TUDOR HALL IN LEONARDTOWN
ST. MARY'S COUNTY, MARYLAND

SITE PLAN
& MAPS

DATE 3-21-89
JOB NO. 87240
DRAWING NO. OF S-1

SECTIONS & DETAILS
DATE 3-21-89
JOB NO. 87240
SMEALLIE, ORRICK AND JANKA, LTD.
ARCHITECTS PLANNERS
5820 YORK ROAD BALTIMORE, MD. 21212
DRAWING NO. OF A-3

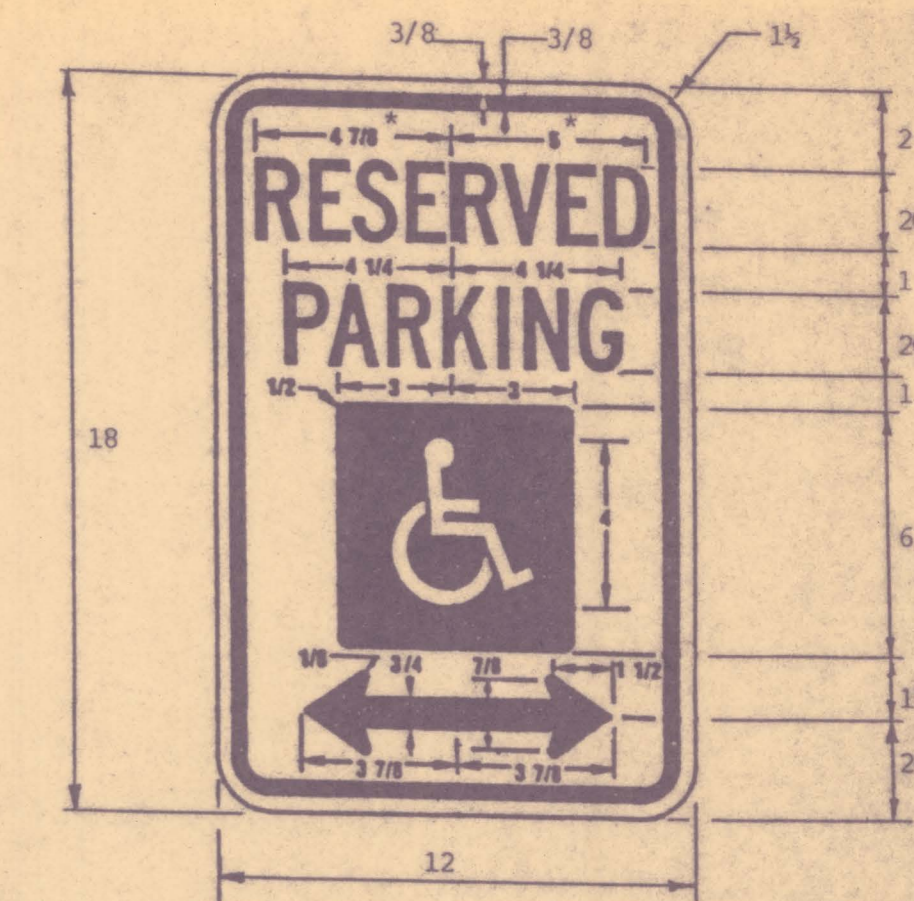
HANDICAPPED SIGN DETAIL
 NO SCALE

*REDUCE SPACING 50 PERCENT

LEGEND AND BORDER — GREEN
 WHITE SYMBOL ON BLUE BACKGROUND
 BACKGROUND — WHITE

NOTE
 SEE SITE PLAN (S-1) FOR
 SIGN LOCATION.

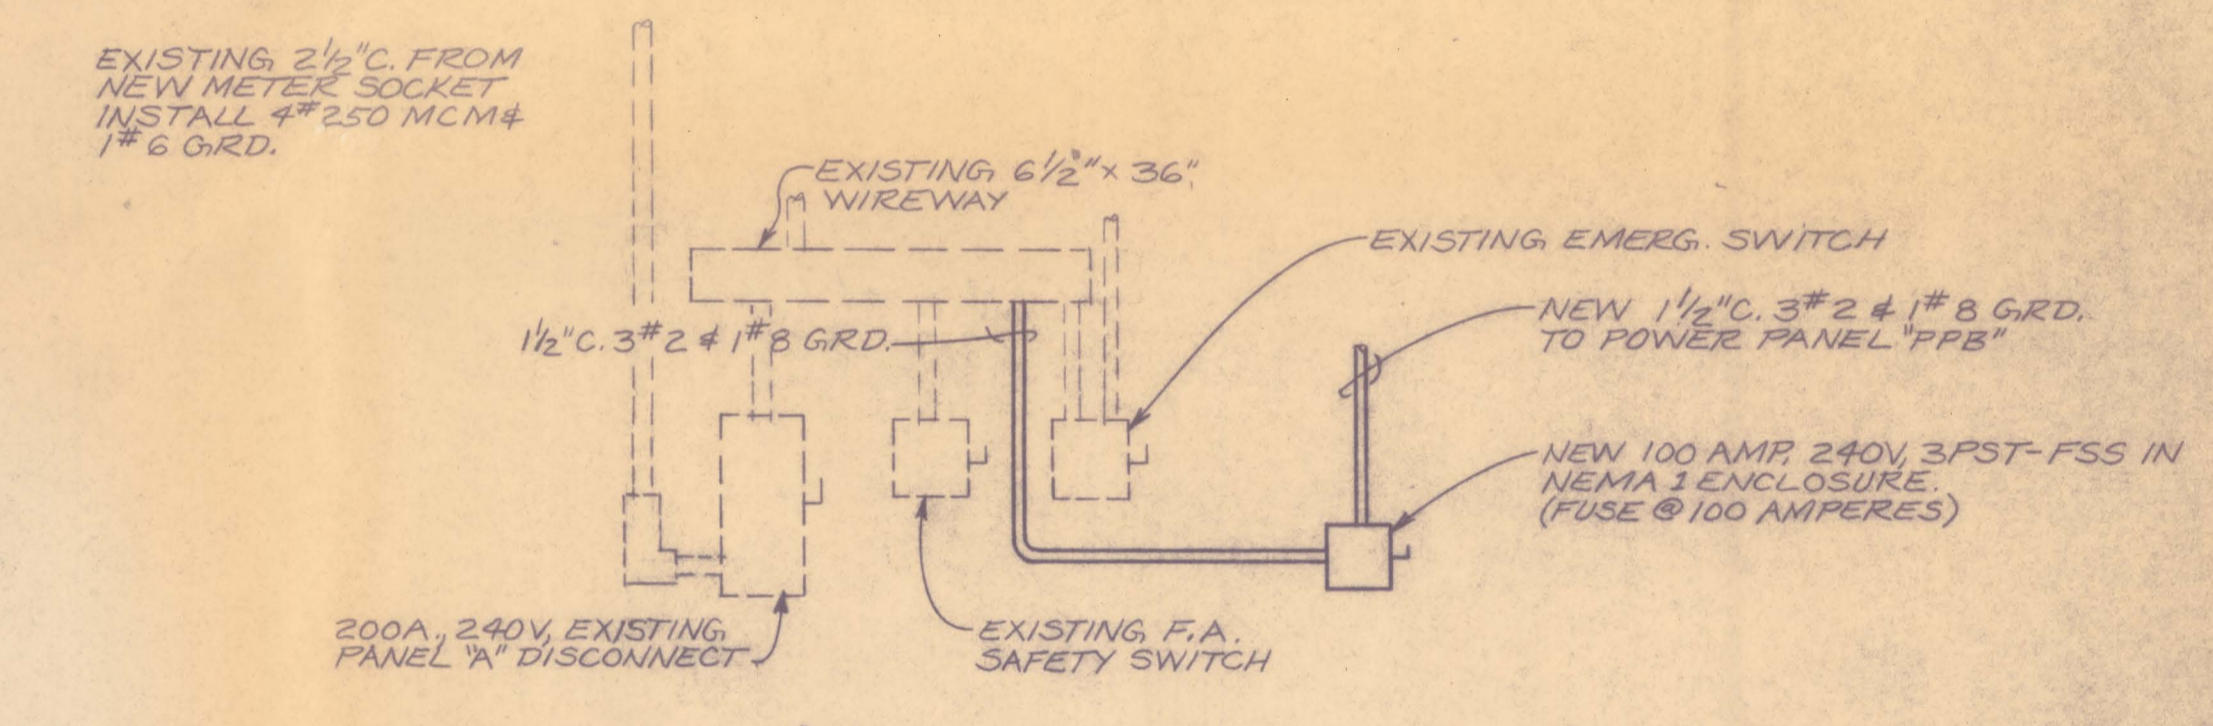
ELEVATION "A-A"

- EXISTING METERING EQUIPMENT TO BE REMOVED. NEW ELECTRIC METER AND SOCKET (FURNISHED BY POWER COMPANY) SHALL BE INSTALLED BY ELECTRICAL CONTRACTOR.
- EXISTING 2 1/2" CONDUIT TO REMAIN AND BE UTILIZED FOR NEW SERVICE ENTRANCE CONDUCTORS. EXISTING 3" & 4" TO BE DISCONNECTED AND REMOVED. INSTALL NEW 4" & 250 MCM & 1" & 6 BRD.
- EXISTING LIGHTING FIXTURES SHALL BE DISCONNECTED AND DELICATED AS INDICATED TO AVOID INTERFERENCE WITH NEW MECHANICAL BULKHEAD.

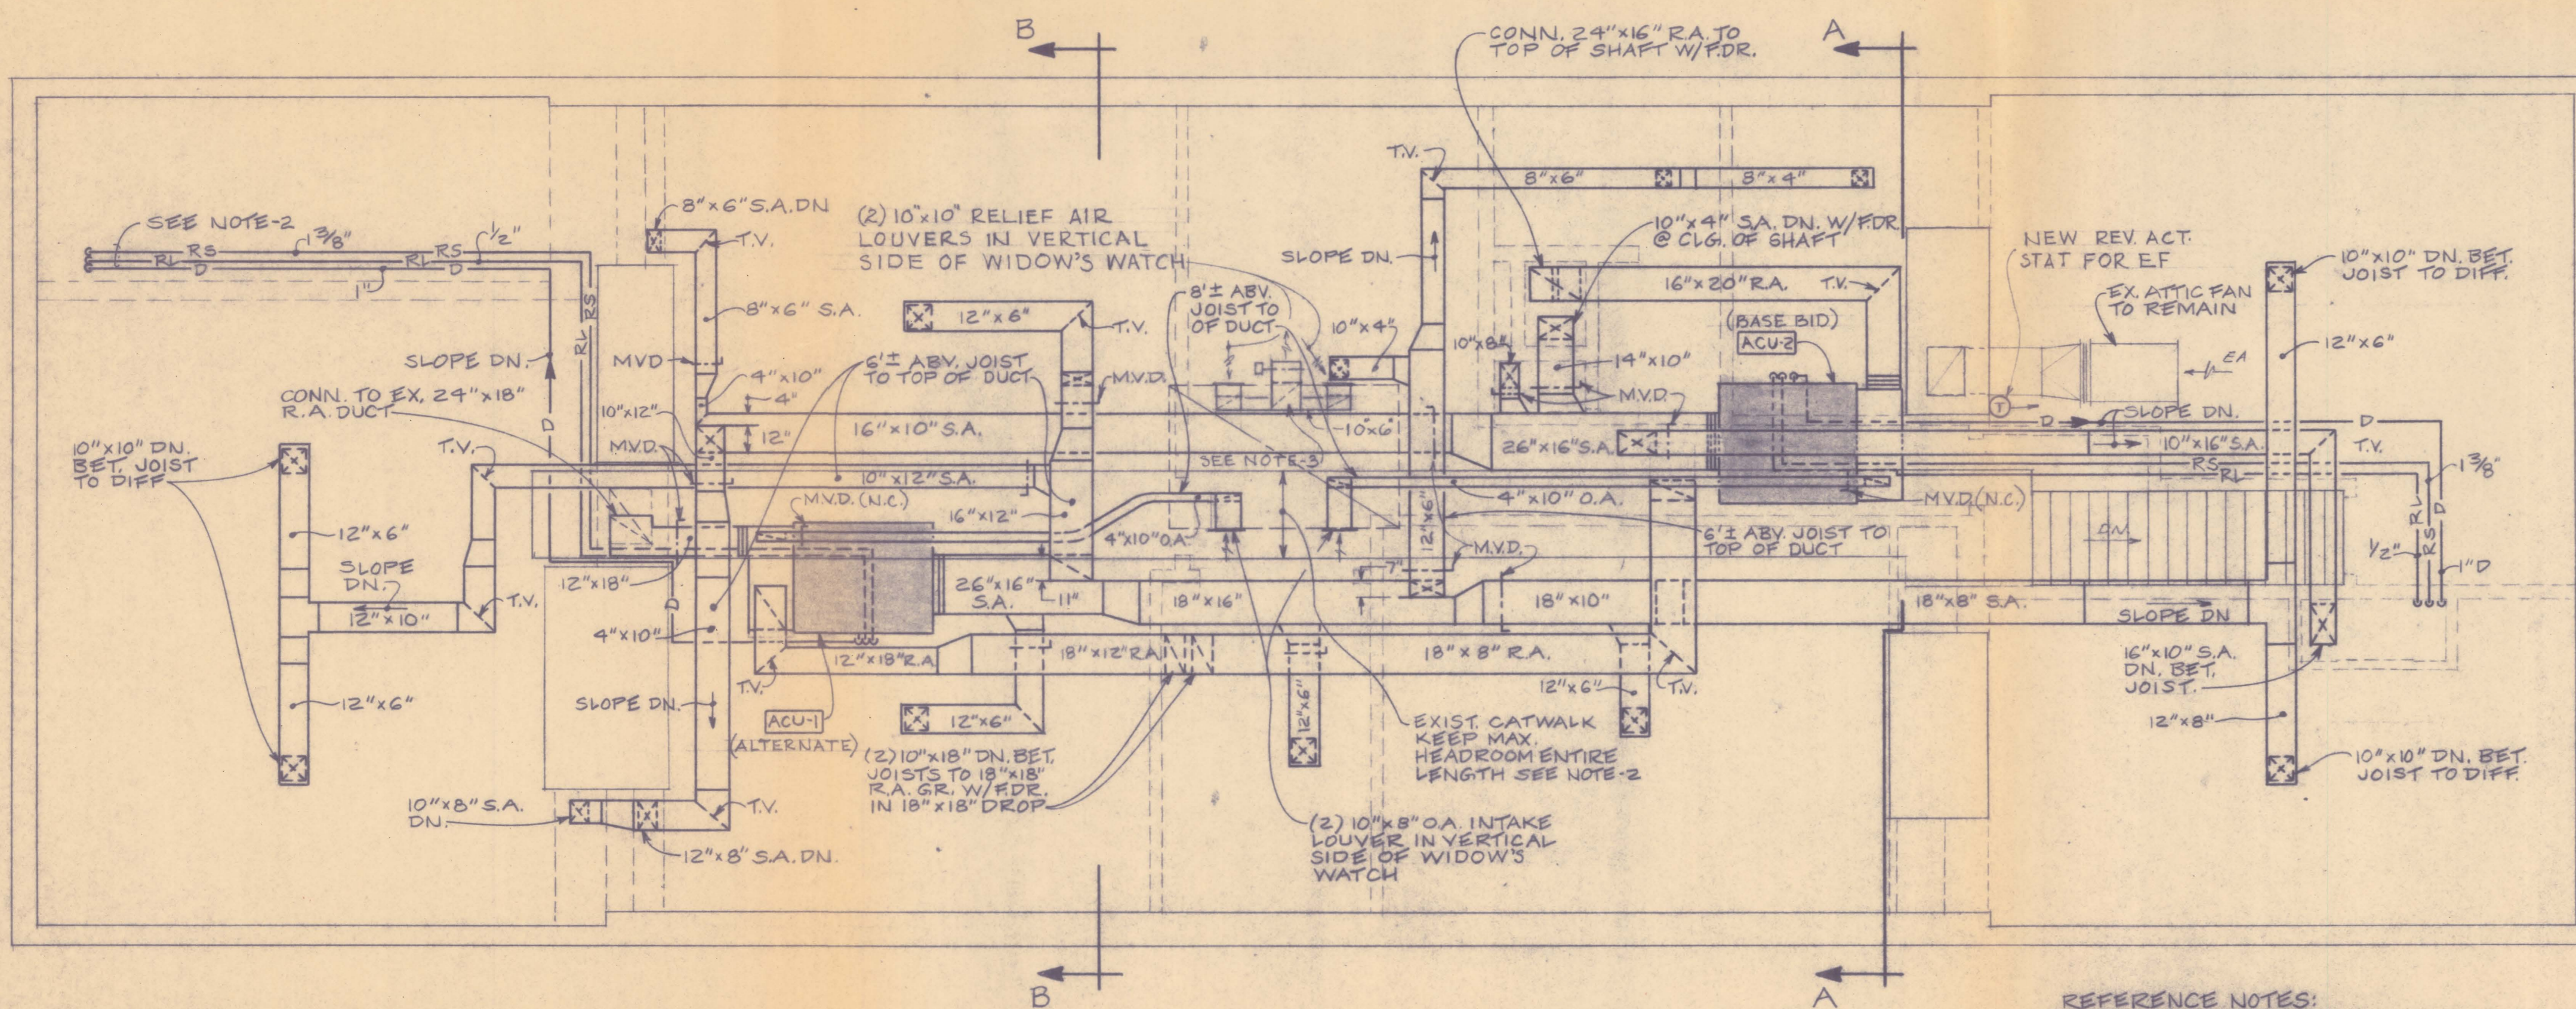
ROOF SPACE PLAN
SCALE: 1/4" = 1'-0"

EQUIPMENT CAPACITIES

SPLIT SYSTEM HEAT PUMP AIR CONDITIONING (ACU-2) - 1ST FLOOR:

3000 CFM @ .60" ESP, 706 RPM, 1-1/2 HP, 208V, 3Ø, 6.3 MCA 91.5 MBH T.C., 67.9 S.C. @ 80° F. WB EAT, 95° F. AHB; 4.10 MBH HTG. CAP @ 70° F. INSIDE, 12° F. OUTSIDE. TRANE BWA 0903M FAN COIL WITH BTA 090C3M CONDENSING UNIT (41 MCA MAX @ 240V, 3Ø, 60 HZ. APPROVED EQUAL UNITS OF CARRIER, MCQUAY, OR YORK SHALL BE CONSIDERED.

SPLIT SYSTEM HEAT PUMP AIR CONDITIONING (ACU-1) - 2ND FLOOR

3000 CFM @ .50" ESP, 674 RPM, 1-1/2 HP, 208V, 3Ø, 6.3 MCA 91.5 MBH T.C., 67.9 S.C. @ 80° F. DB, 67° F. WB EAT, 95° F. AHB. 41.0 MBH HTG. CAP. @ 70° F. INSIDE, 12° F. OUTSIDE. TRANE BWA 0903M FAN COIL WITH BTA 090C3M CONDENSING UNIT (41 MCA MAX @ 240V, 3Ø 60 HZ.). APPROVED EQUAL UNITS OF CARRIER, MCQUAY, OR YORK SHALL BE CONSIDERED.

- 1- REMOVE SHELVING AND SUPPORTING MEMBERS ALONG WALKWAY IN ATTIC AS REQUIRED FOR DUCTWORK & UNITS; SEE ARCH. NOTES & SPEC.
- 2- REFRIGERANT PIPING SIZES ARE APPROX. - FINAL SIZES SHALL BE RECOMMENDED BY MFGR OF APPROVED EQUIP.
- 3- PROVIDE MOTOR OPERATED DAMPER IN 12"x12" INTAKE DUCT OPEN TO ROOF SPACE. INTERLOCK M.O. DAMPER WITH EXISTING ROOF EXHAUST FAN.

NOTES
1 REMOVE EXISTING SHELVING IN ATTIC SPACE TO ACCOMMODATE NEW MECHANICAL EQUIPMENT.
2 REPAIR CEILING & FLOORS AS NECESSARY, AFTER DUCTWORK IS INSTALLED.
